**BURNED AREA**

**FLASH FLOODING**

# SHARED VIEWS

News and Information for the Communities of the Bitterroot National Forest

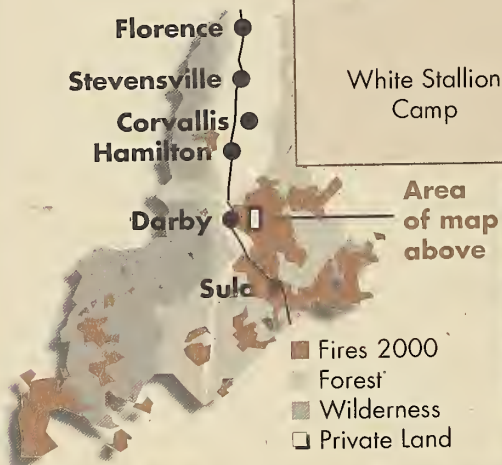
When the rains fell, areas throughout the valley were impacted. It was especially so where the fire in such as the Laird Child Creek drainage. These aerial photos were taken during flights to identify all damage from the intense rains.

Mudslides created alluvial fans like the one pictured above right of the Skalkaho Creek drainage. Other alluvial fans were also found that washed into Sleeping Child Creek, several miles away from any development, roads or past logging activity. Biologists from Montana Department of Fish, Wildlife and Parks, Department of Environmental Quality, and the Forest Service are monitoring the impacts the sedimentation is having on channels, fish and other aquatic life.

alluvial fan in Skalkaho Creek drainage  
blowdown in Sleeping Child Creek drainage

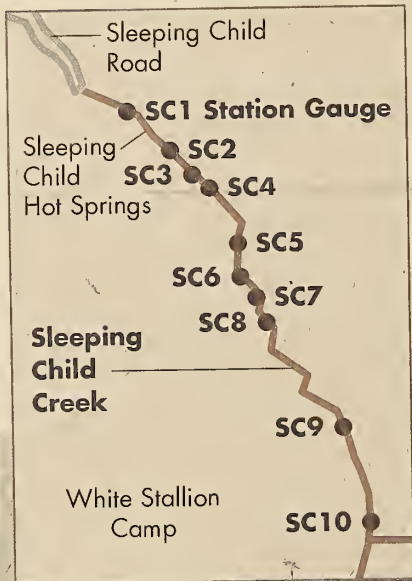
Left: map showing sites where slides occurred in the Sleeping Child Creek drainage

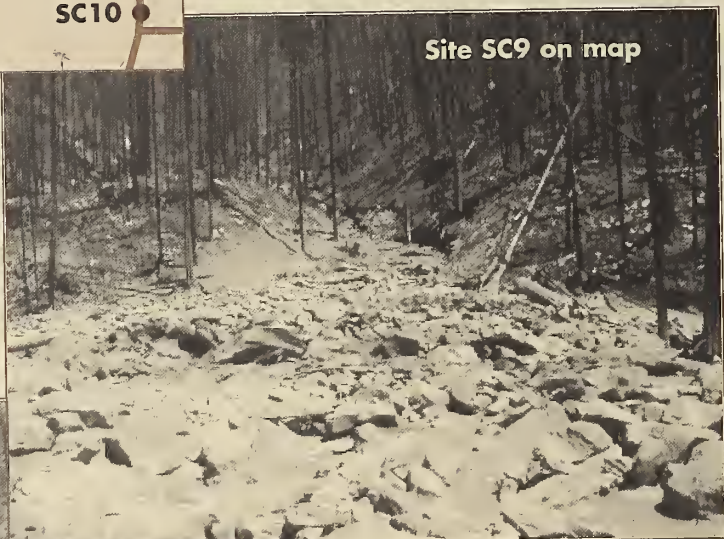
Site SC9 on map

Left: debris flowed from this natural gully and created the fan of material. It moved Sleeping Child Creek 50 feet to the south and buried the existing trail with small boulders, rocks and soil.

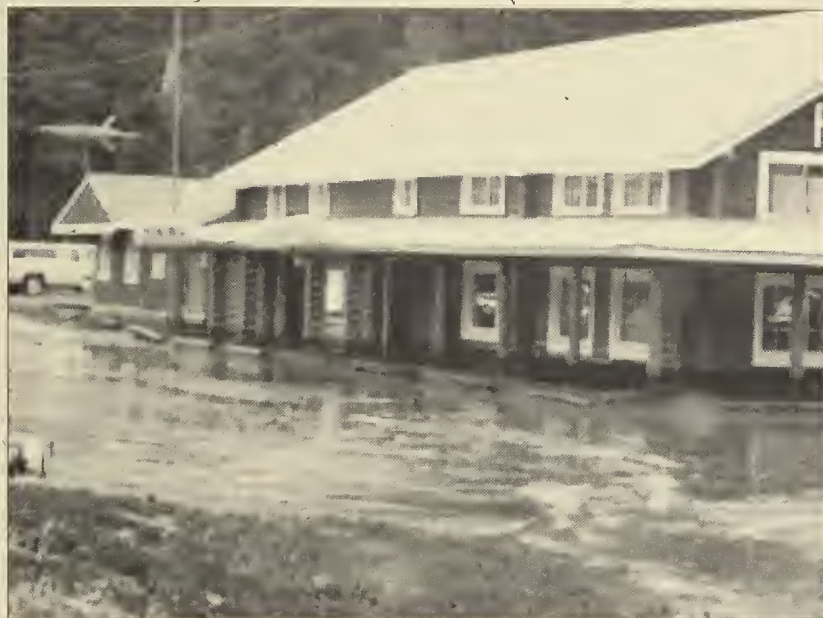
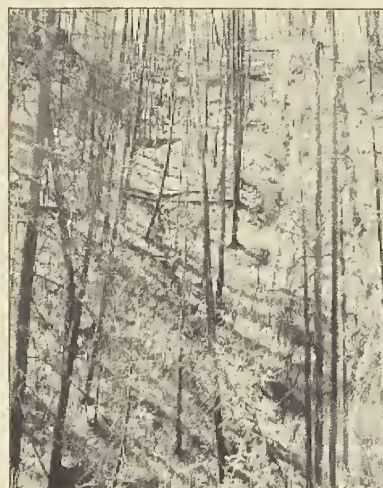
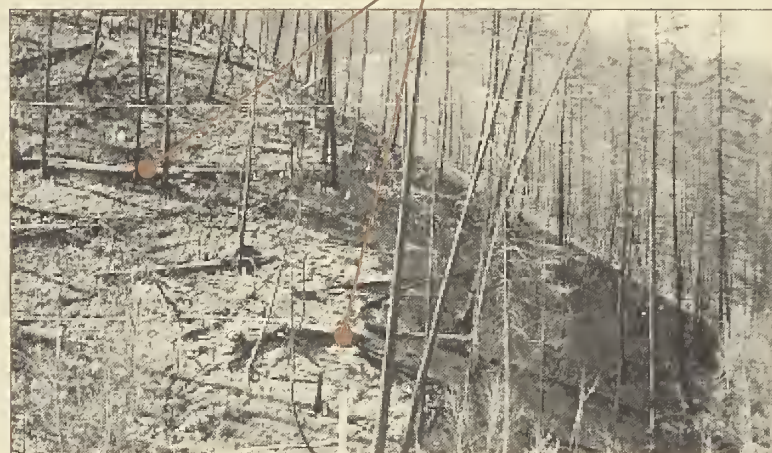
Straw wattles, contour log felling and hydromulching native grass seed proved to help mitigate the destructive impacts of the floods. These photos taken of the hillsides on the south side of Laird Creek on July 25, show how the BAER efforts did help. Though there was some channelling and mudslides, a lot of the burned hillsides held up.

*Below: flooding at the Rocky Knob Cafe below Laird Creek*

*Left: hillside on the south side of Laird Creek Road seeded through hydromulching techniques*

*Below: straw wattles and contour felled logs on the same south side of Laird Creek Road*

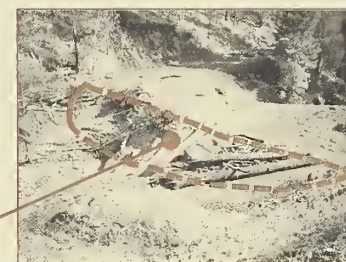
This was one of many culverts that was replaced last fall. It is located on Forest Service Road 106-A, 3 miles south of Sula, MT, east of US Highway 93. The old culvert, 18 inches in diameter, was replaced with a four foot diameter culvert. The picture (right) shows mud and debris that washed out part of the road. The mud and debris continued down the hillside (left) and created damage to two homes at the bottom near Camp Creek. Though there was some road damage, the culvert held up and kept the road from completely washing out.

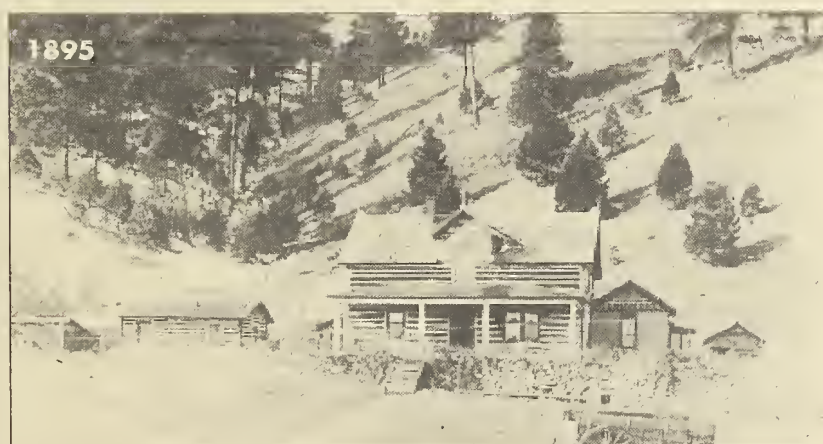
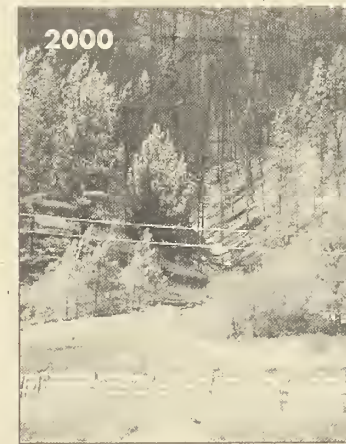
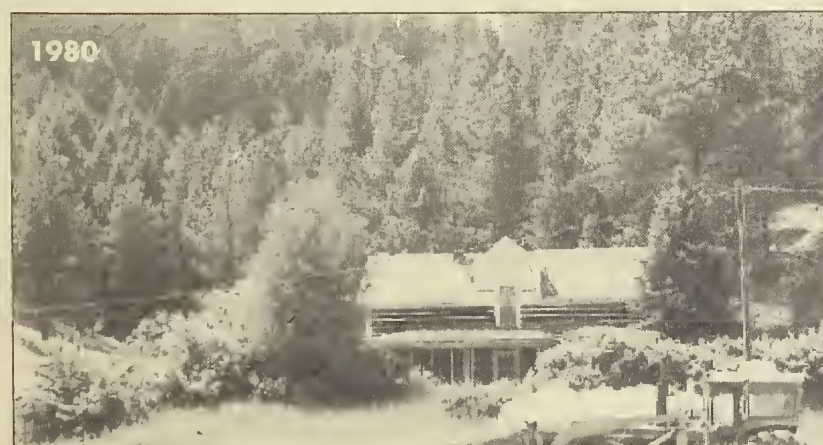
1895: this is what a ponderosa pine forest looked like before fire suppression practices allowed other tree species to flourish and create a densely forested area.

1980: this is the same site 85 years later. With the absence of fire, the forested area behind the homestead became very dense. It changed from a fire dependent and resistant ponderosa pine forest to a mixed conifer forest dominated by Douglas fir.

2000: The densely forested area behind the homestead provided enough fuels to maintain the high intensity burn that passed over the area. Fortunately, the home seen in the previous pictures had been moved some years prior to the fire.

2001: Heavy rains on July 21 and 22 caused a mudslide that travelled down the draw and crossed the East Fork Road.

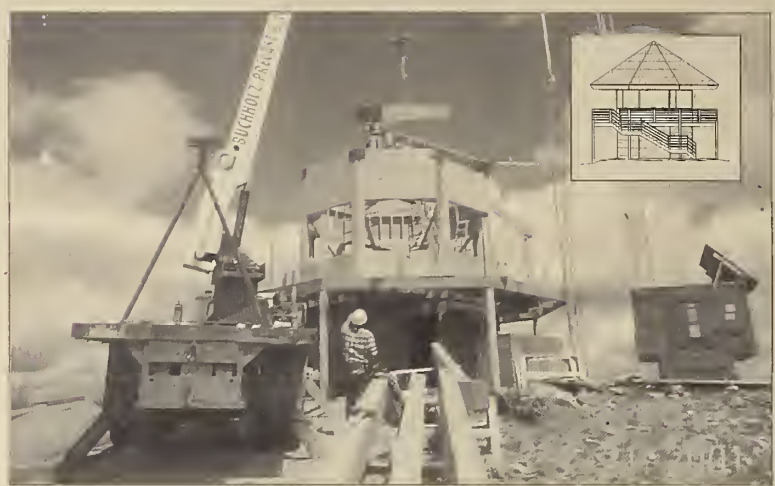
## THE SULA PEAK LOOKOUT

*Work on the Sula Peak Lookout is moving right along. By the end of July, the contractor was setting the roofing support beams in place. The Lookout should be completed by the end of September*
